A Case Study of the Stuart Richardson House (Glen Ridge, NJ), 1941)

BY LAWRENCE J. TARANTINO AIA

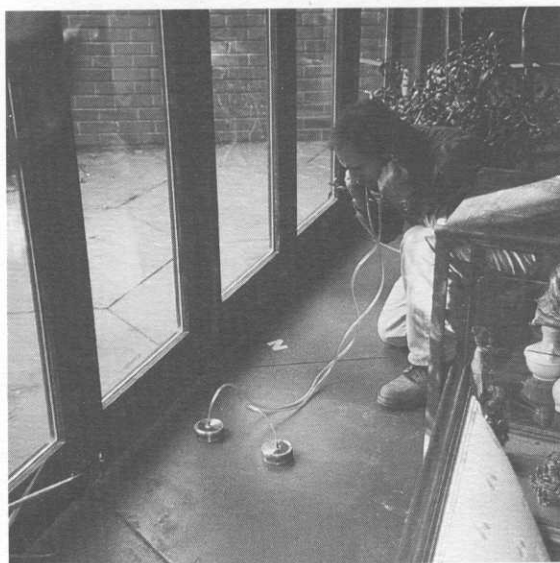
Lawrence Tarantino with electronic stethoscope.

There are a number of different methods which can be used to locate pipes and leaks. Several area companies were contacted for equipment information and availability. A local municipal water department employee provided a service to locate underground water leaks with an electronic stethoscope. It was necessary to remove the flow control and pressure safety valves because of the amplified noise interference they emitted through the pipes. To narrow down the areas of examination, we relied on experience, background knowledge from research, visual inspection, and clues. The suspect areas included certain types of cracks and small spots of white efflorescent chalking. Once a suspect area was located with the electronic stethoscope, small holes were drilled through the concrete slab and probed to confirm the presence of moisture. A section of the floor was removed by cutting along the existing unit line joints with a saw and then hammering out the concrete, taking care not to damage adjacent pipe in good condition.

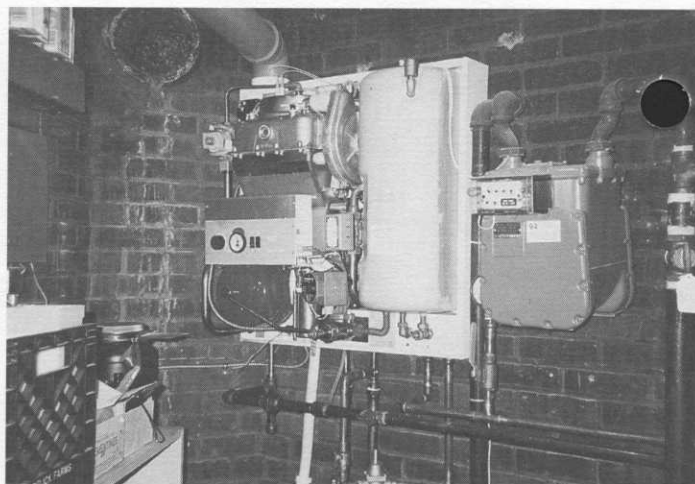
New furnace.
