## A Case Study of the Stuart Richardson House (Glen Ridge, NJ), 1941)

BY LAWRENCE J. TARANTINO AIA

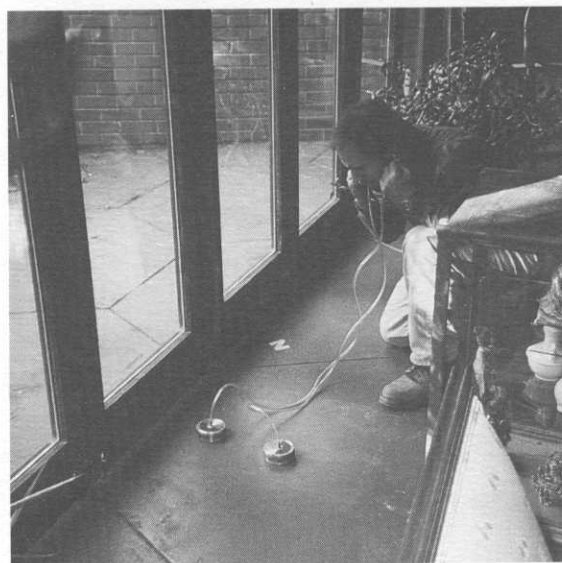
Lawrence Tarantino with electronic stethoscope.

There are a number of different methods which can be used to locate pipes and leaks. Several area companies were contacted for equipment information and availability. A local municipal water department employee provided a service to locate underground water leaks with an electronic stethoscope. It was necessary to remove the flow control and pressure safety valves because of the amplified noise interference they emitted through the pipes. To narrow down the areas of examination, we relied on experience, background knowledge from research, visual inspection, and clues. The suspect areas included certain types of cracks and small spots of white efflorescent chalking. Once a suspect area was located with the electronic stethoscope, small holes were drilled through the concrete slab and probed to confirm the presence of moisture. A section of the floor was removed by cutting along the existing unit line joints with a saw and then hammering out the concrete, taking care not to damage adjacent pipe in good condition.

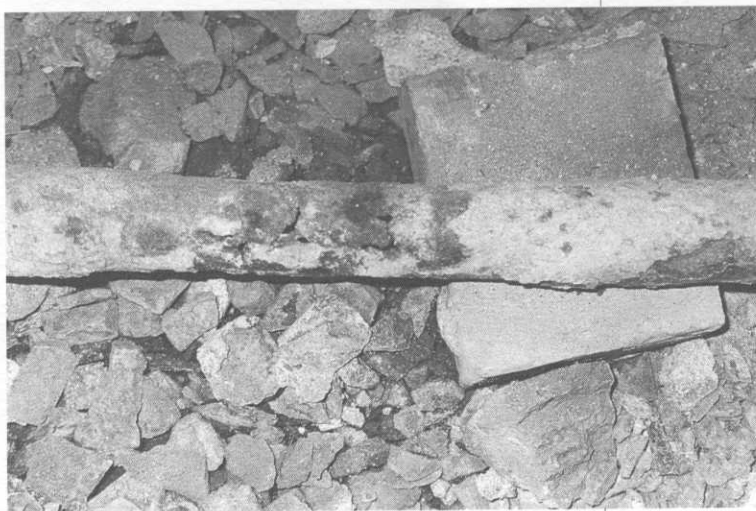
Deteriorated pipe after concrete was removed.

rol the time-sensitive finishing process. The area of the primary leak was immediately obvious and, although the pipe was found to be partially cast into the concrete rather than having been installed just under the crushed stone base, the failure did not appear to be caused from its contact with the concrete. The damage and the condition of the pipe in the vicinity of the leak were catastrophic, and the initial consensus was to give up any consideration of repairing it. After four sections of the floor were removed, we could identify a concentrated area of deterioration along the mid-section of the terrace doors

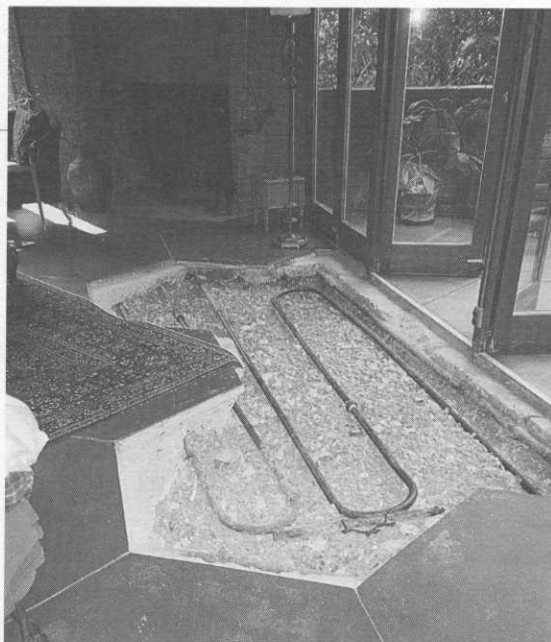
Final repair after (3) hex. units and (2) half hex. units of concrete were removed to repair additional deteriorated pipe.

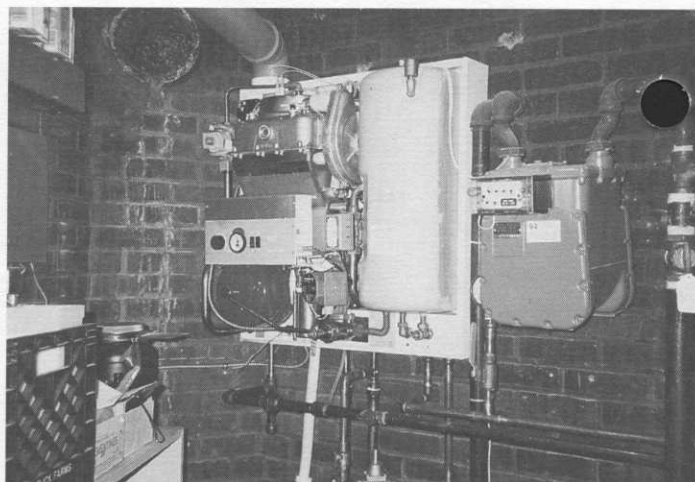
New furnace.
